## **OLYMPIC & TITANIC: REFINING A DESIGN**

By Mark Chirnside

**This article was first published in the British *Titanic Society's Atlantic Daily Bulletin* December 2019: Pages 18-22.**

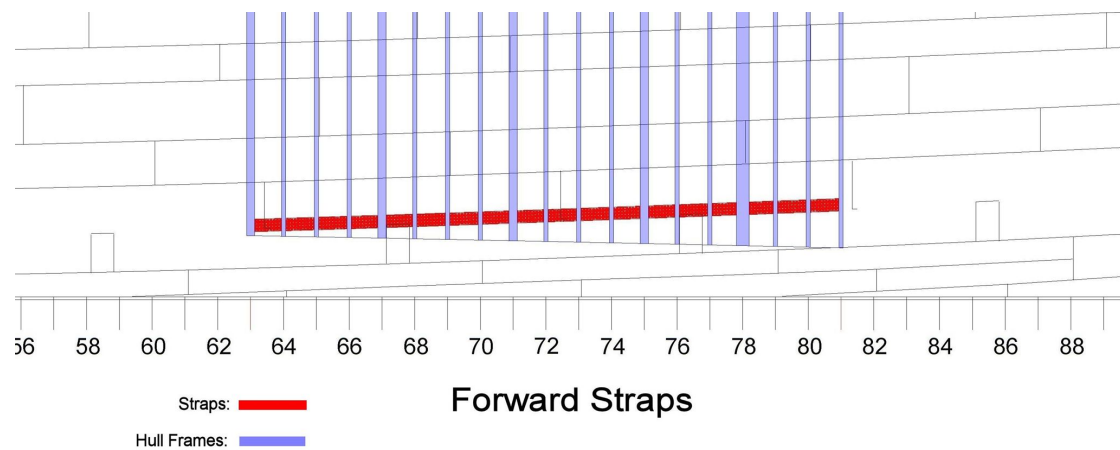
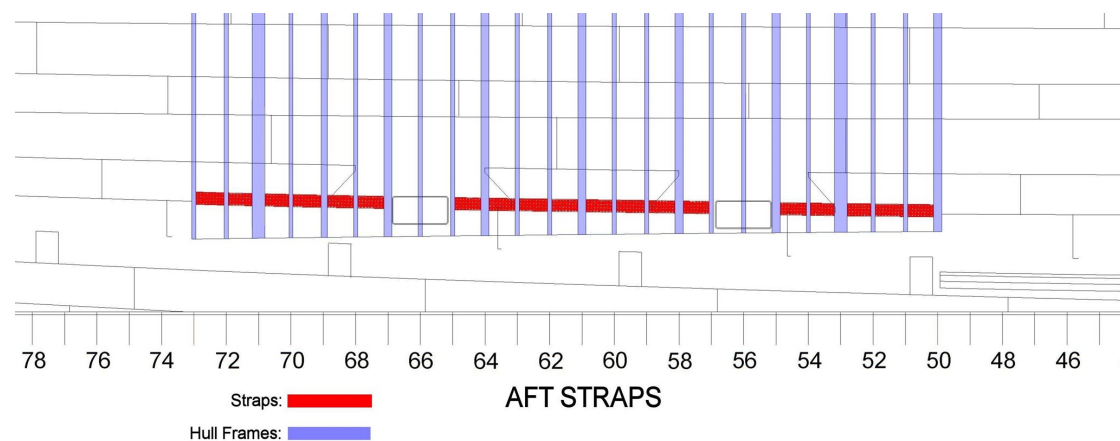
Above and below: These diagrams show close up views of the location of the 'straps' added fore and aft on *Titanic*. The thicker vertical hull frames are 'web' frames, which added enormously to the strength of the hull structure. Unlike some other ships of the period, whose hull frames were numbered consecutively, on *Olympic* and her sisters the numbering system started from the middle of the ship. Therefore numbers were duplicated and we see frame number 60 (forward) and frame number 60 (aft). (Bob Read © 2019)
